Joe Weaver Pool and Spa Inspection Report

January 23rd | 302 Utica Ave, Tulsa OK 74104

14. Swimming Pools, Equipment and Safety

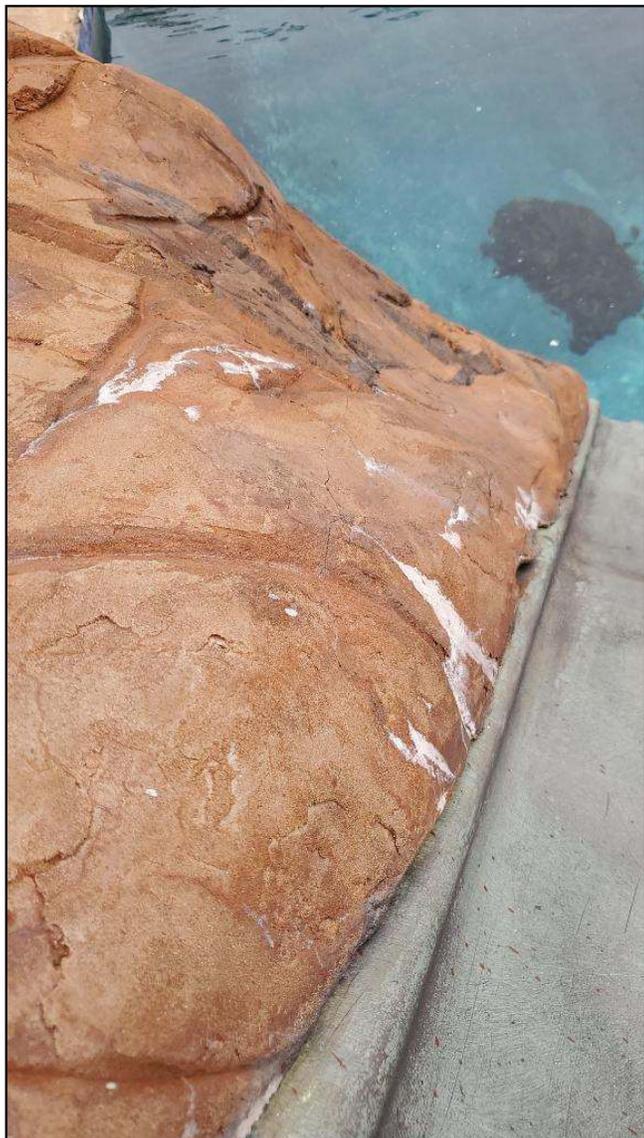
14.0 Item 1(Picture)

14.0 (1) Efflorescence at the water feature. This indicates moisture is getting between the materials. I recommend qualified contractor repair or replace as needed.

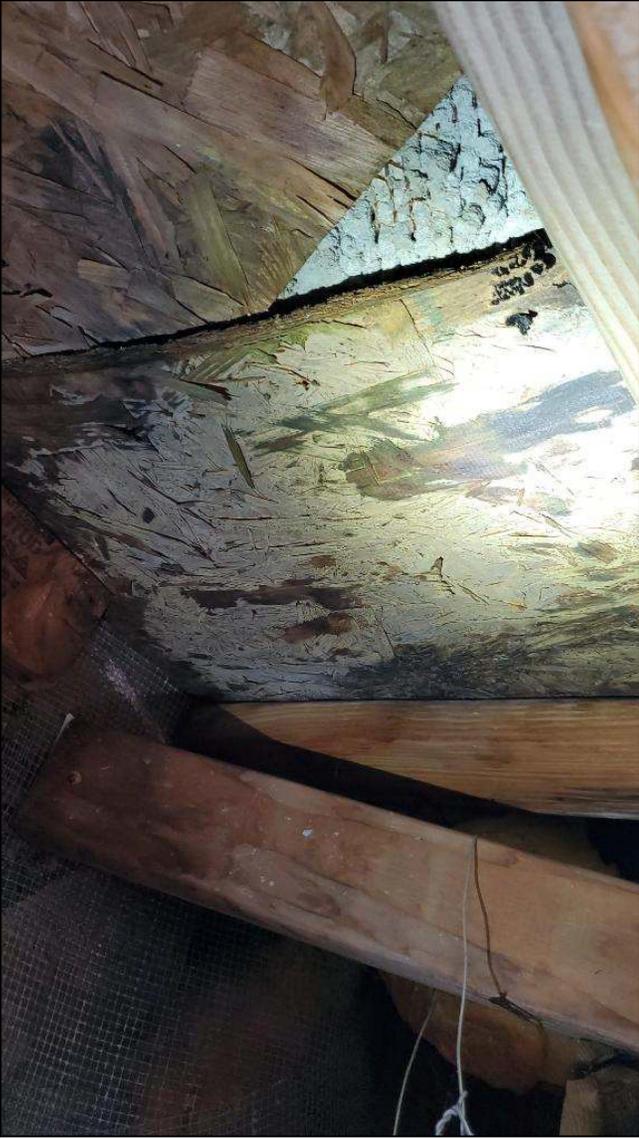
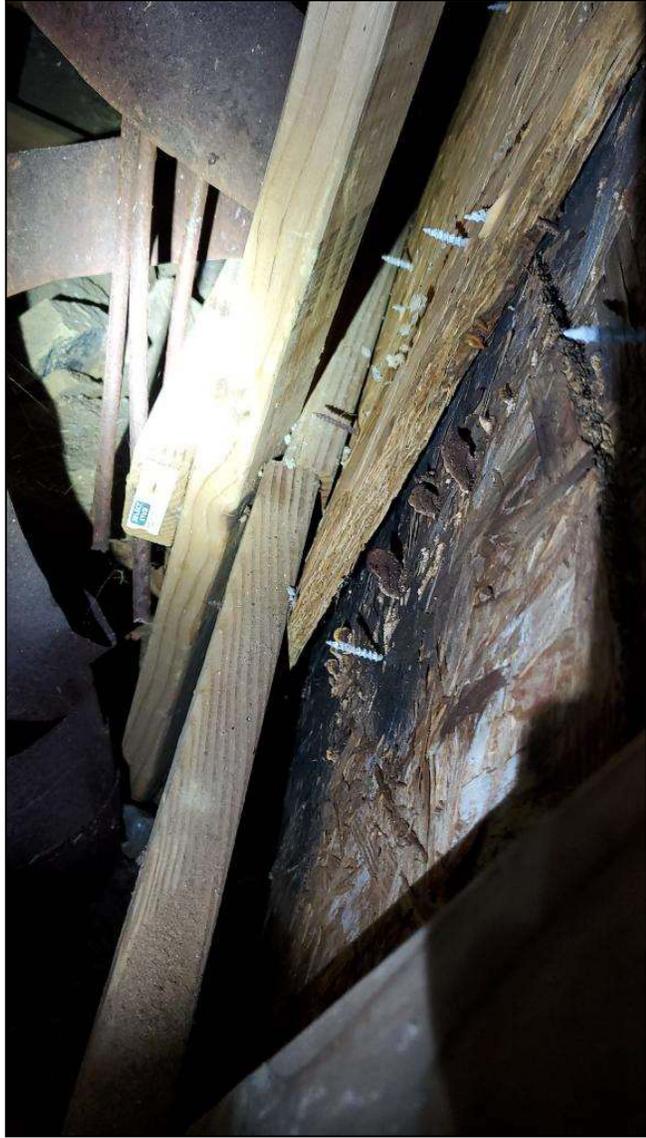
(2) Deteriorated sheeting at the interior of the water feature. Indications of previous moisture intrusion. I recommend qualified contractor repair or replace as needed.

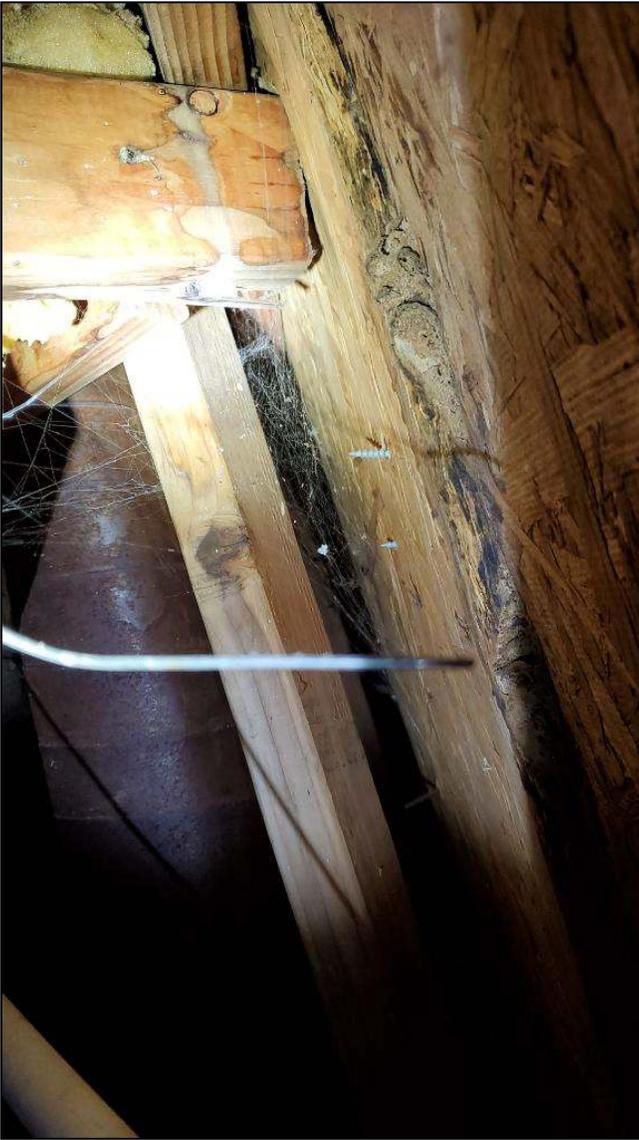
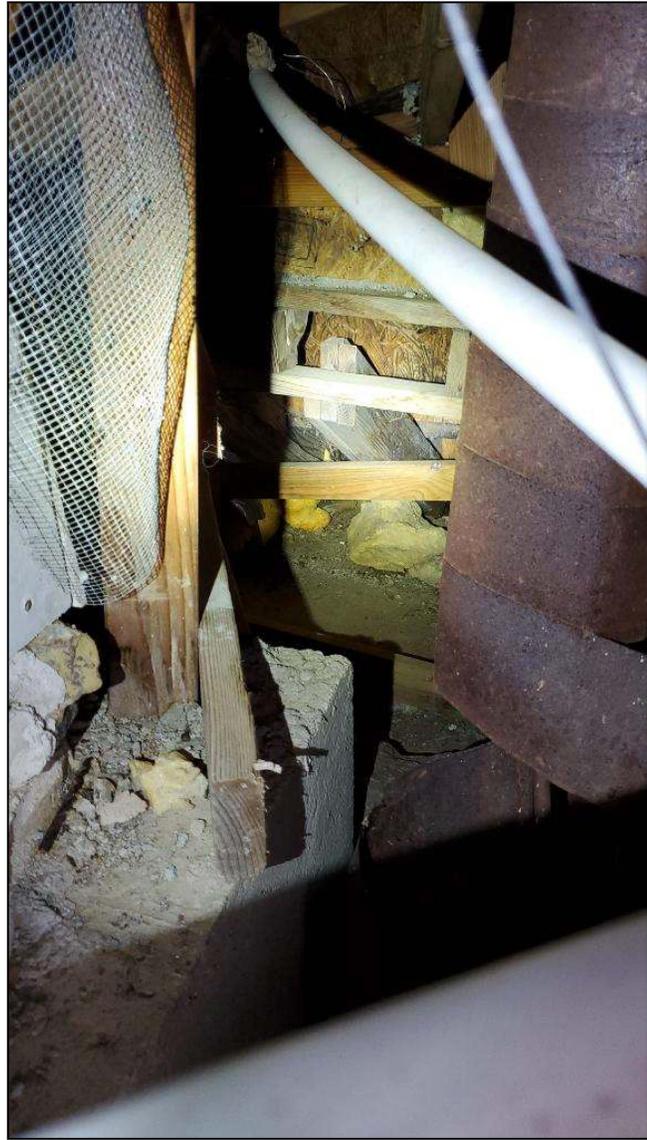
No cover at the water feature rear. This is allowing moisture intrusion. I recommend qualified contractor repair or replace as needed.

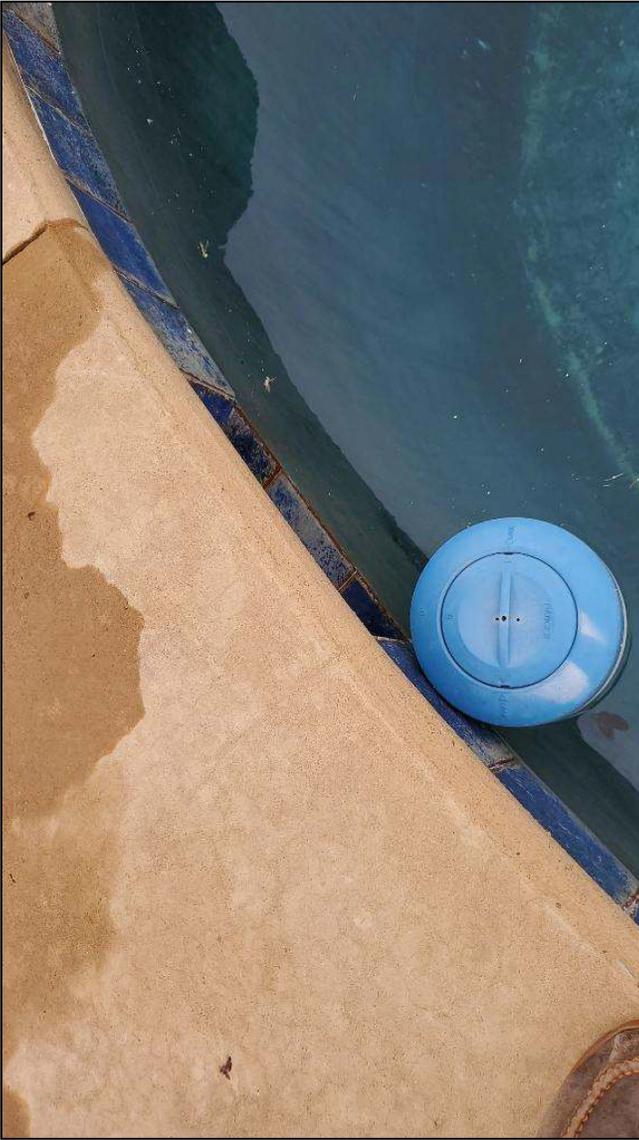
14.0 Item 7(Picture)

(3) Water level low at the pool. This is preventing the water from flowing into the skimmer properly. Pool should be properly filled.

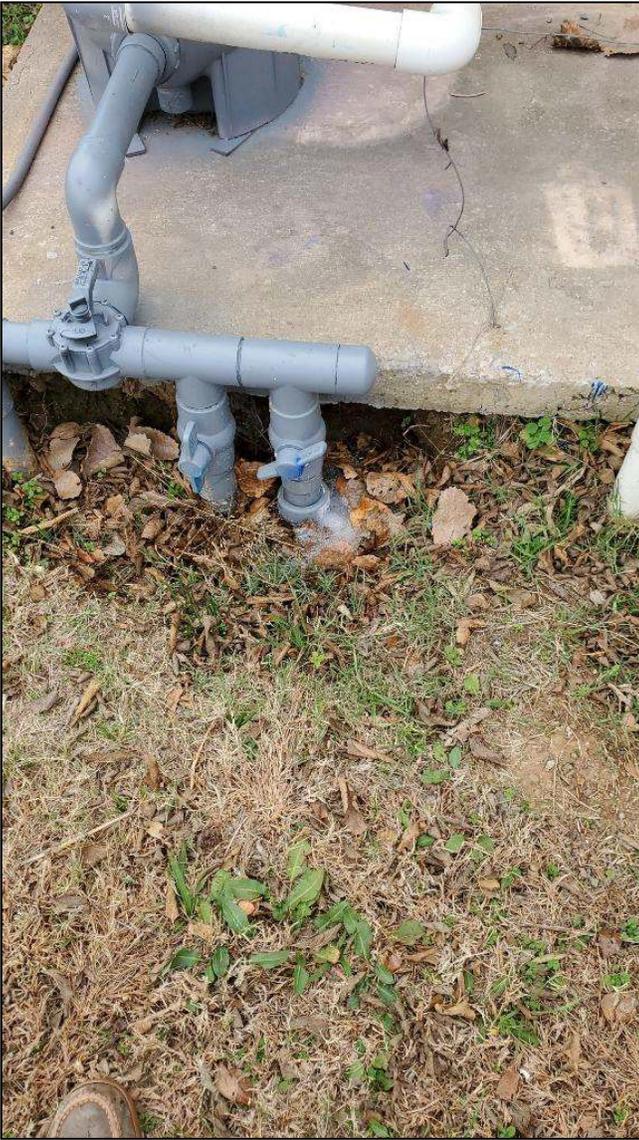
14.0 Item 8(Picture)

(4) Leak at the water feature plumbing fitting. Water feature could not be tested/operated. I recommend qualified contractor repair or replace as needed and test water feature for proper operation.

Erosion at the pool equipment pad. This should be addressed to prevent equipment from moving over time. I recommend qualified contractor repair or replace as needed.

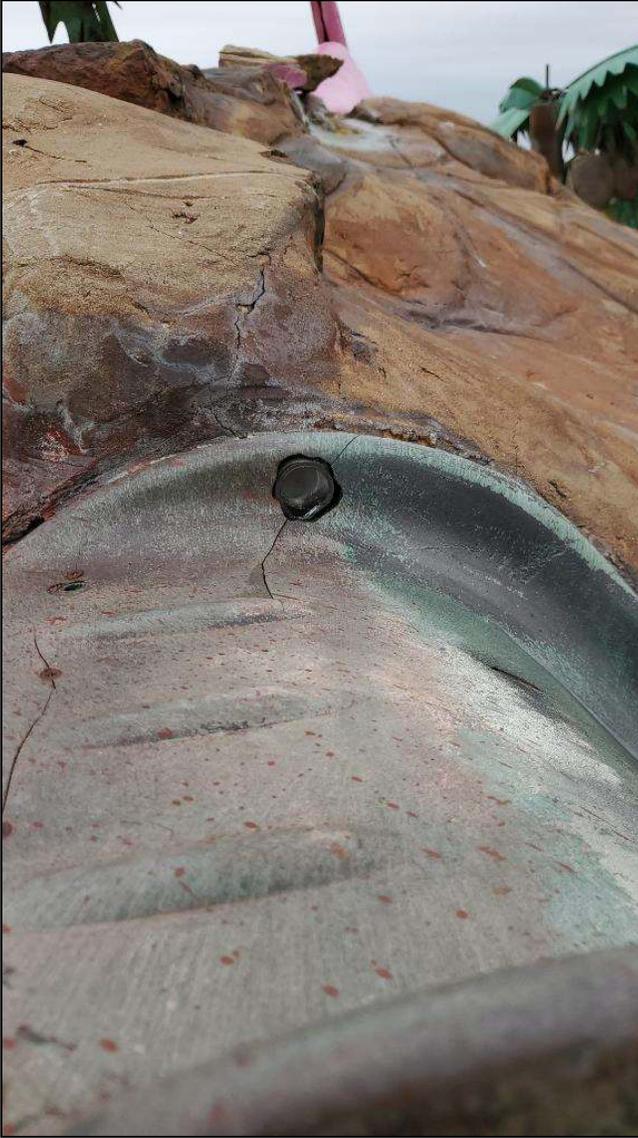
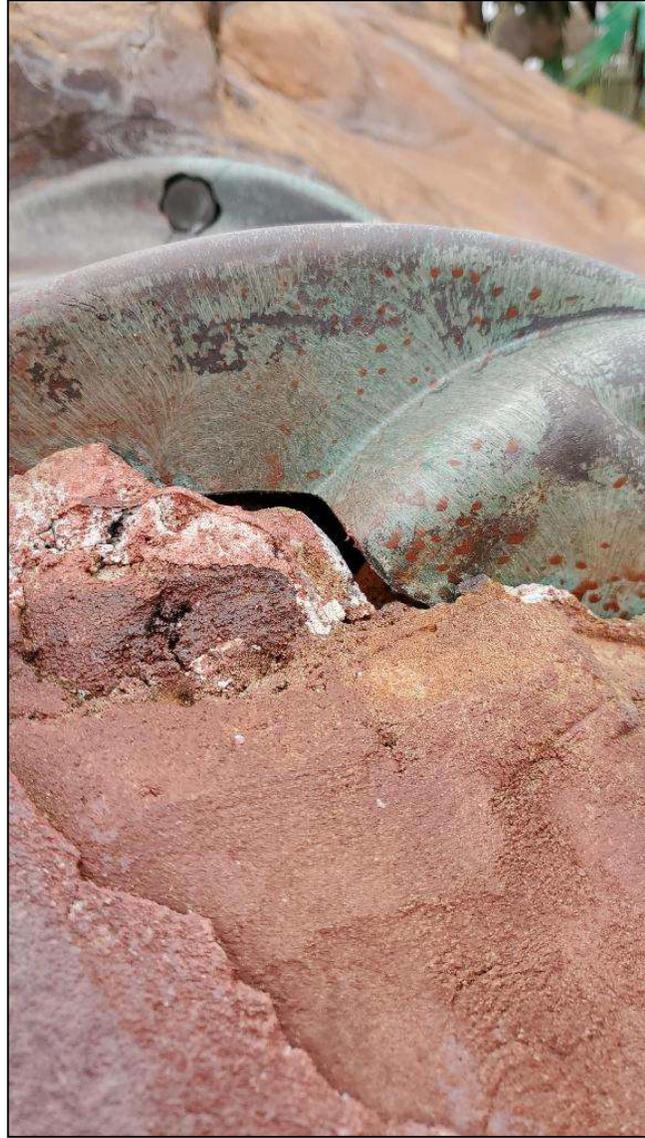
(5) The pool slide is cracked/damaged. Gaps at the side of the pool slide. This will allow moisture to enter. I recommend qualified contractor repair or replace as needed.

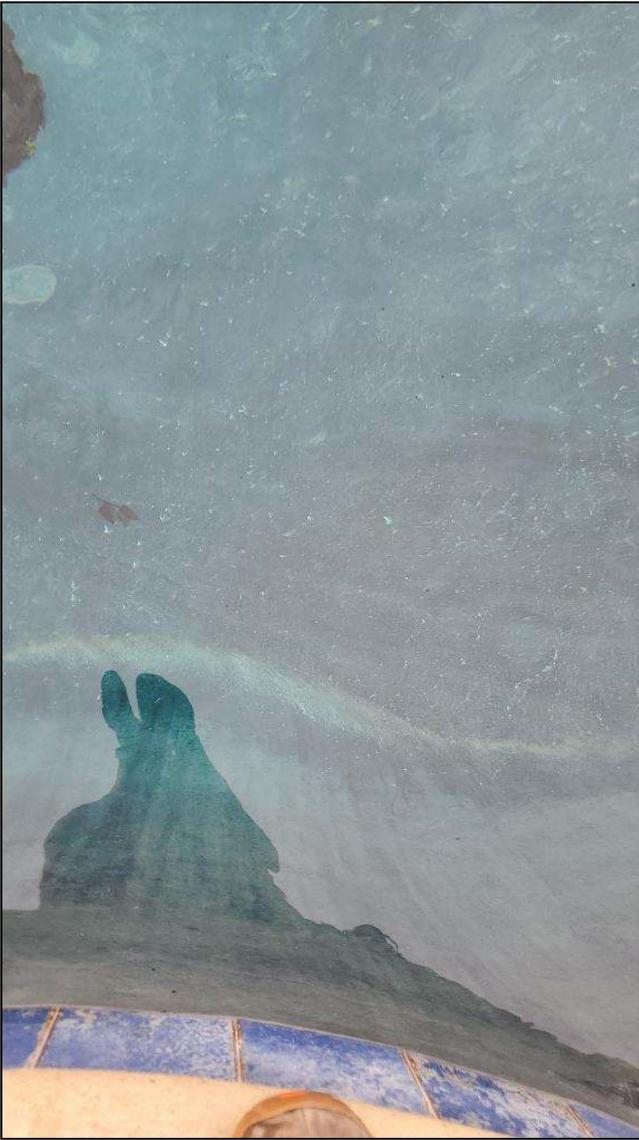
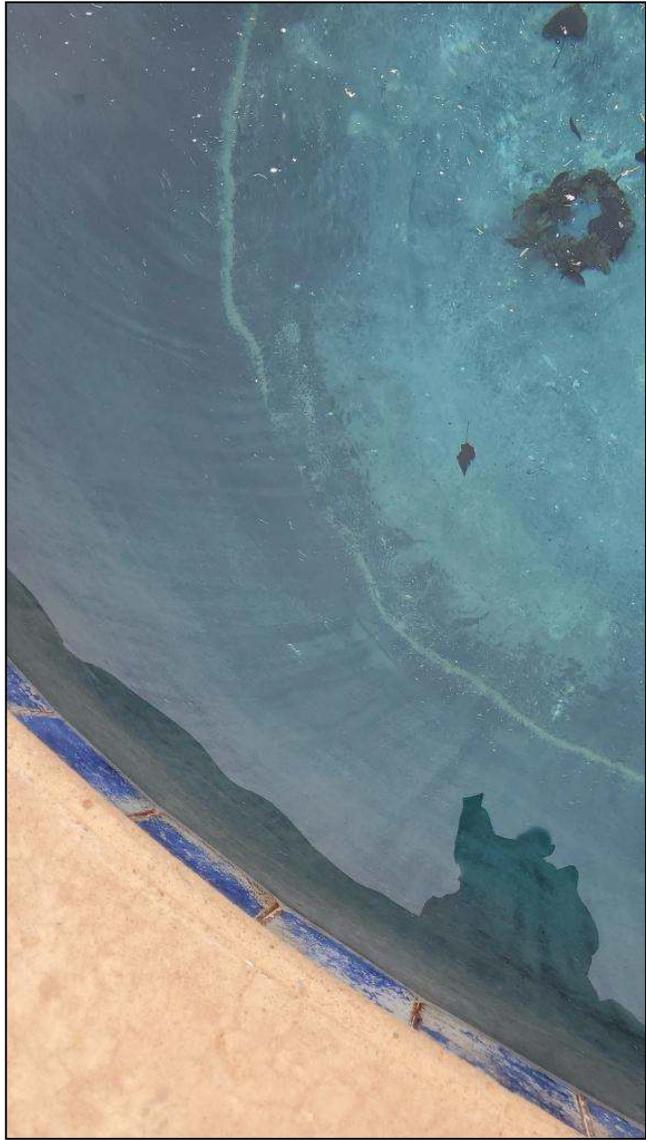
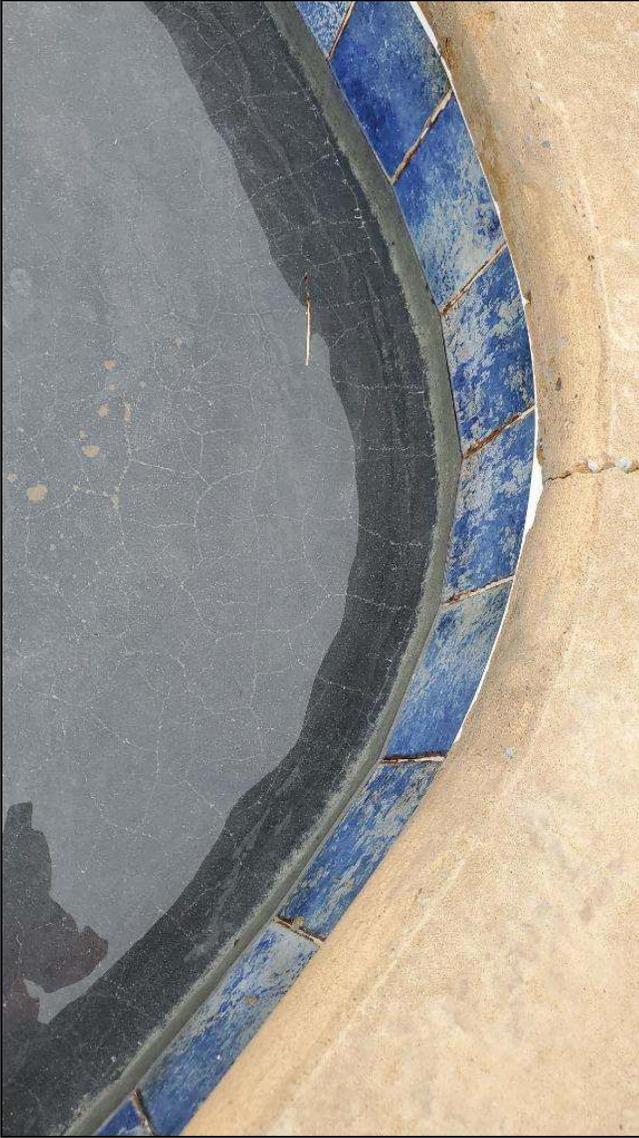
14.2 There is some efflorescence and cracking at the pool finish in several areas. Repair may be desired. Further deterioration may occur over time.

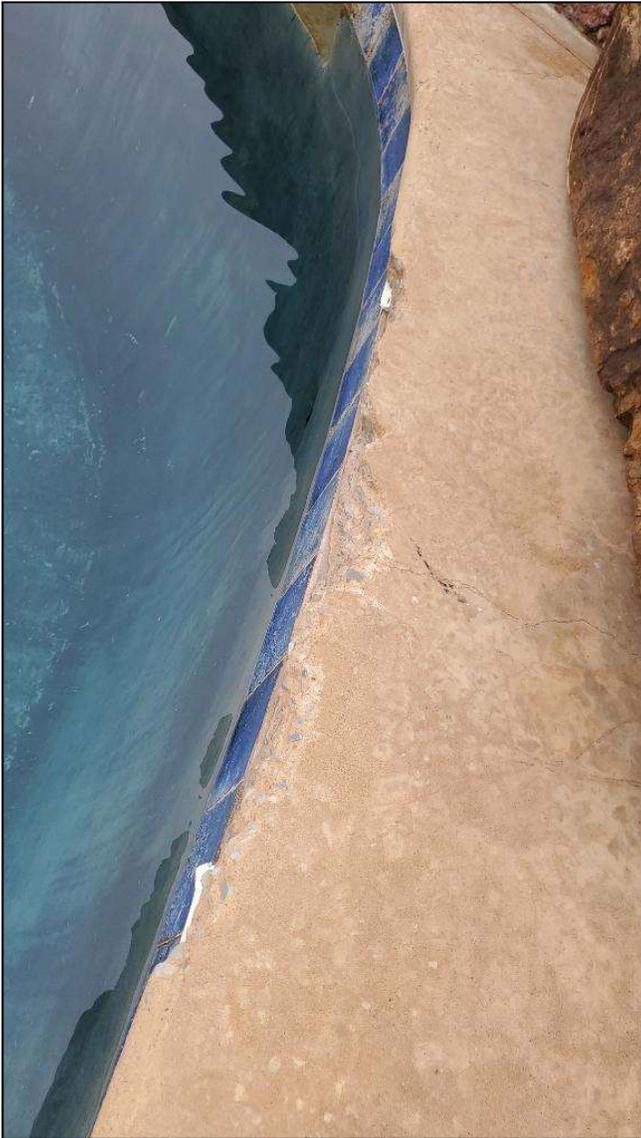
14.7 Item 1(Picture)

14.7 Damage at the pool deck coping. I recommend qualified contractor repair or replace as needed.

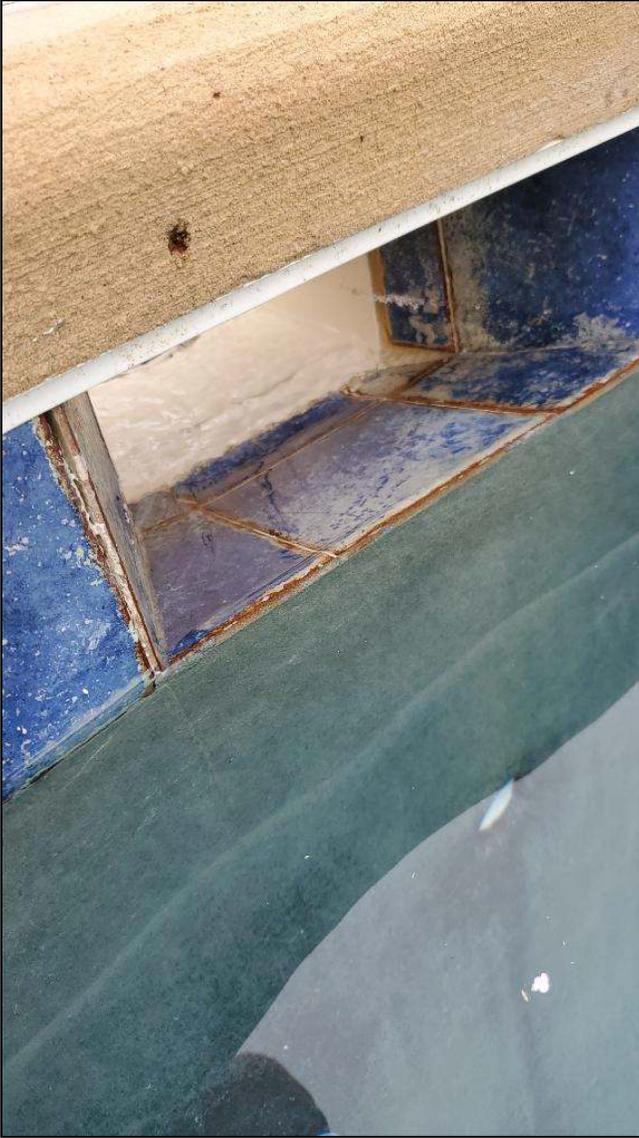
14.9 Item 1(Picture)

14.9 No weir door at the pool skimmer. Installation of a weir door is recommended for increased skimming action of the pool. I recommend installation by qualified contractor.

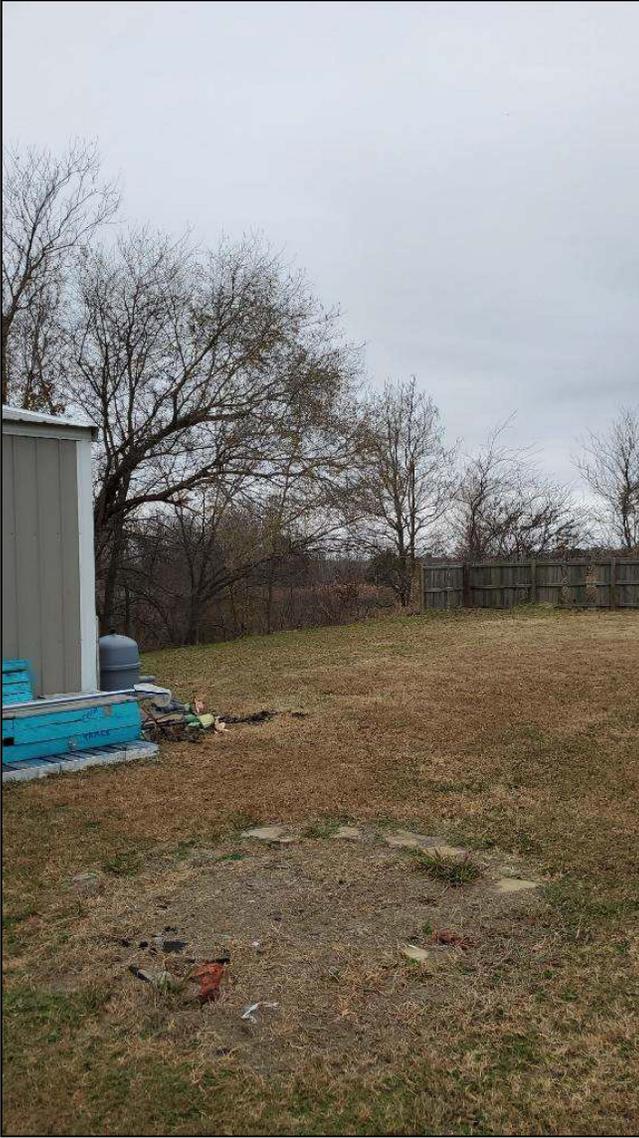
14.16 Item 1(Picture)

14.16 The pool is not fully fenced. This is a safety concern. I recommend fence be installed for safety.

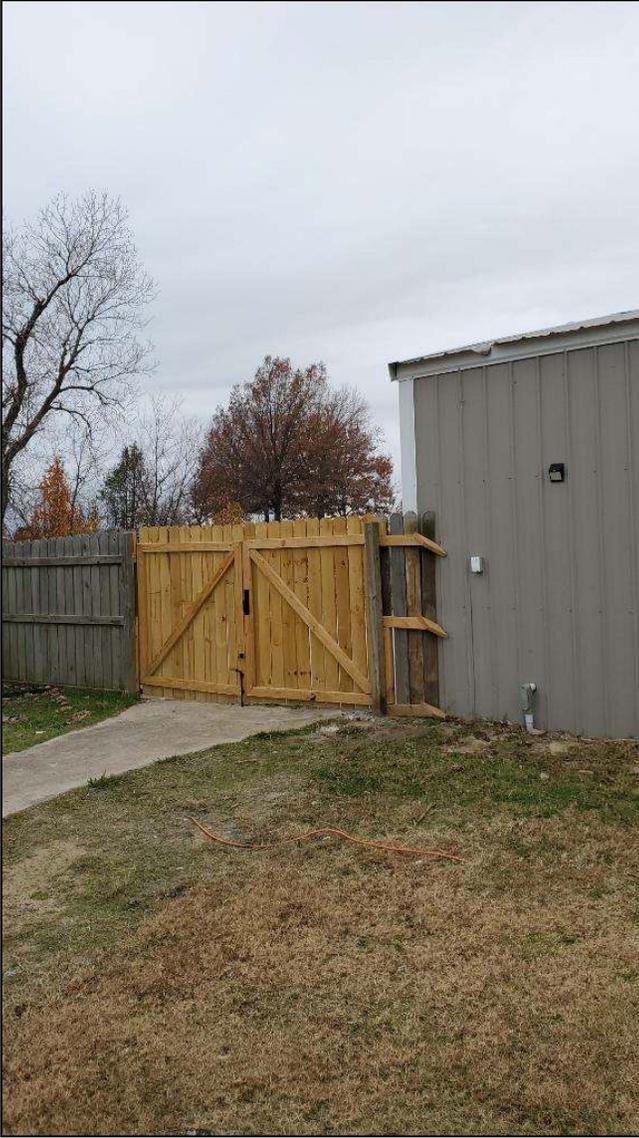
14.17 Item 1(Picture)

14.17 The pool gate does not have self closing hardware or a lock. This is a potential safety concern. I recommend self closing hardware and lock(s) be installed as needed.

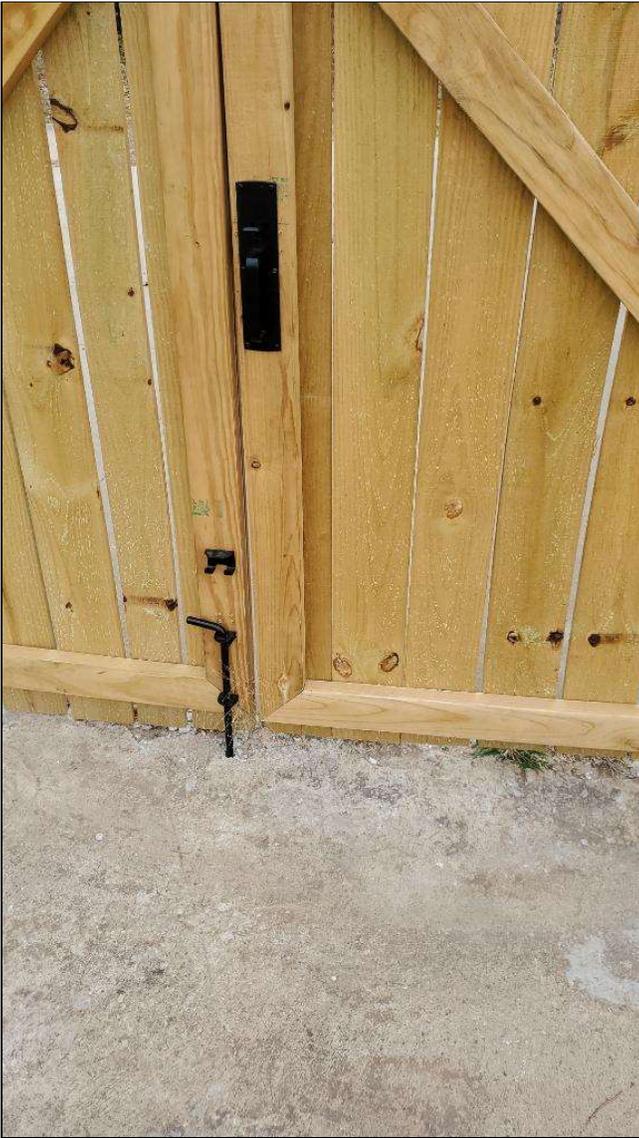
14.18 Item 1(Picture)

14.18 The pool gate latch height does not prevent child from opening the gate. Installation of higher latches/locks is recommended for safety.

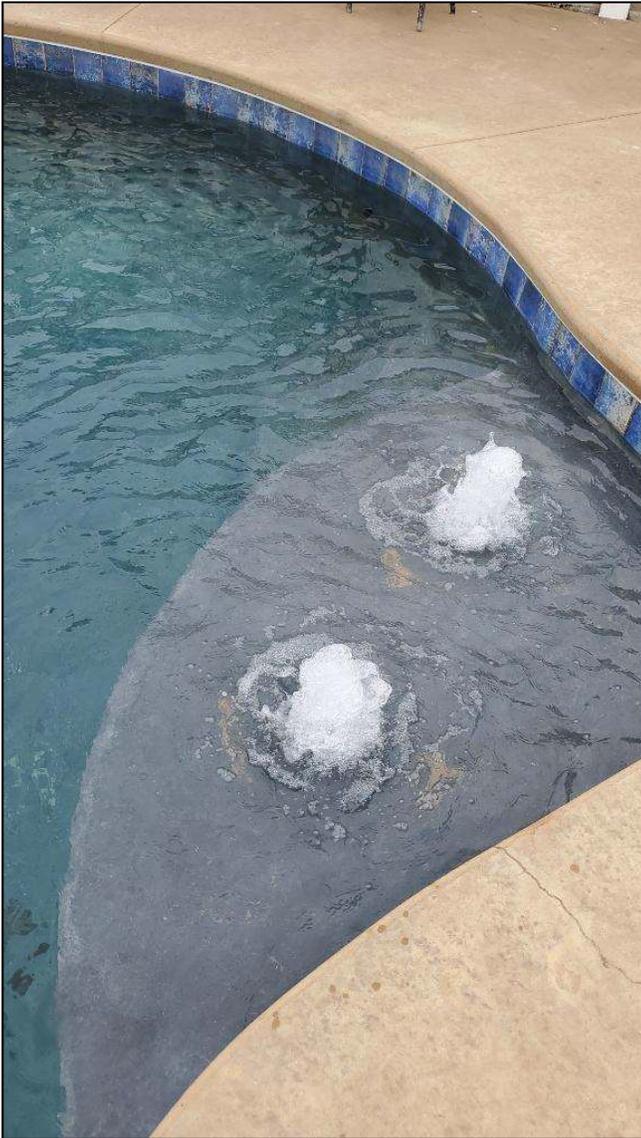
14.23 Item 1(Picture)

14.23 The pool steps/protrusions do not have contrasting color. Contrasting colors are recommended for improved safety. I recommend contrasting colors be installed by qualified contractor.
