Joe Weaver Sewer System Inspection Report

January 23rd | 302 Utica Ave, Tulsa OK 74104

6. Plumbing System

IN	NI	NP	RR
6.0	Plumbing Drain, Waste and Vent Systems				•

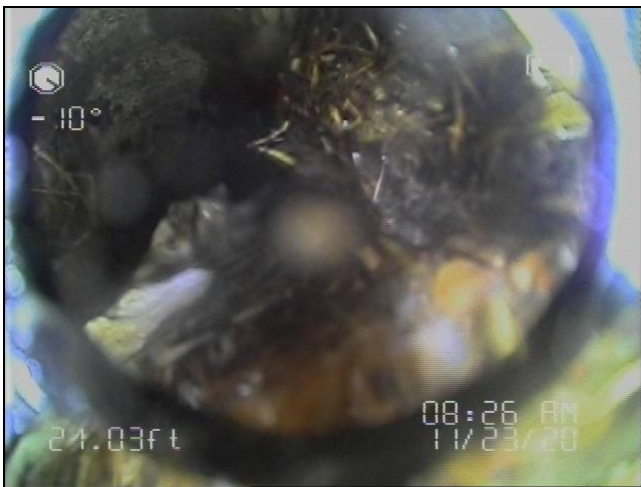
6.0 Item 1(Picture)

6.0 Sewer camera inspection was completed at the property. Root intrusion was observed in multiple locations. Multiple areas of damage and offsets observed at the pipe. I recommend licensed plumber repair/replace the sewer line.

Sewer camera inspection was completed at the property. Root intrusion was observed in multiple locations. Multiple areas of damage and offsets observed at the pipe. I recommend licensed plumber repair/replace the sewer line.
